# COLLECTION OF ALUMINIUM FROM BUILDINGS IN EUROPE

A Study by Delft University of Technology

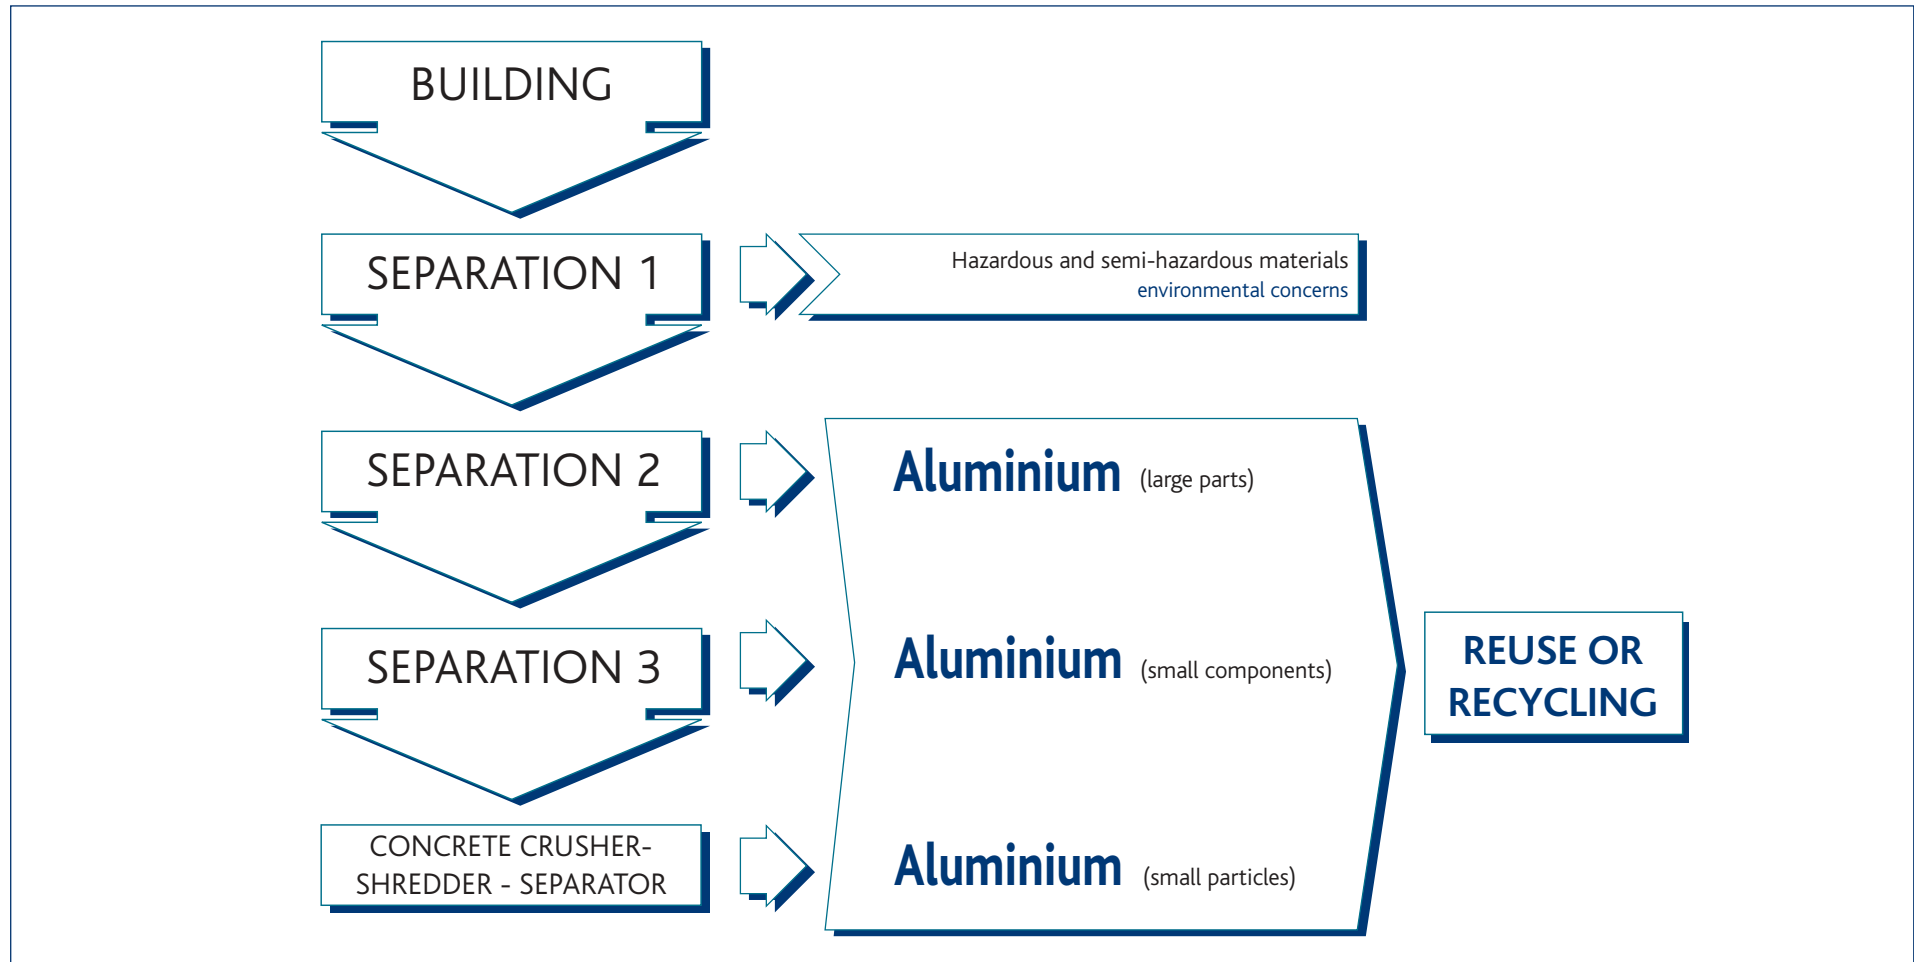
## SIMPLIFIED SCHEME

The deconstruction and demolition of buildings in Europe must be executed in a highly organized manner according to strictly regulated procedures, implemented as a result of both local initiatives and, increasingly, European Union directives. Extensive regulations focus primarily on the separation and handling of hazardous materials, recycling policies and disposal issues. Demolition companies are commonly large contractors operating with a number of subcontractors, employed to perform a variety of tasks in the deconstruction process before the actual demolition can take place. In all the 6 countries investigated in this study, a similar approach and similar methods were applied.

The aluminium collected from a building goes to one of several destinations. Some components are immediately sold for reuse in their original application. Some of the metal goes directly to the aluminium recycling plant to be treated and melted down, yielding a recovery rate approaching 100%. Some needs to be processed with a shredder for mixed scrap to recover the aluminium before re-melting. Only a small percentage is lost unless a recovery system is in place at the disposal site or incineration unit.

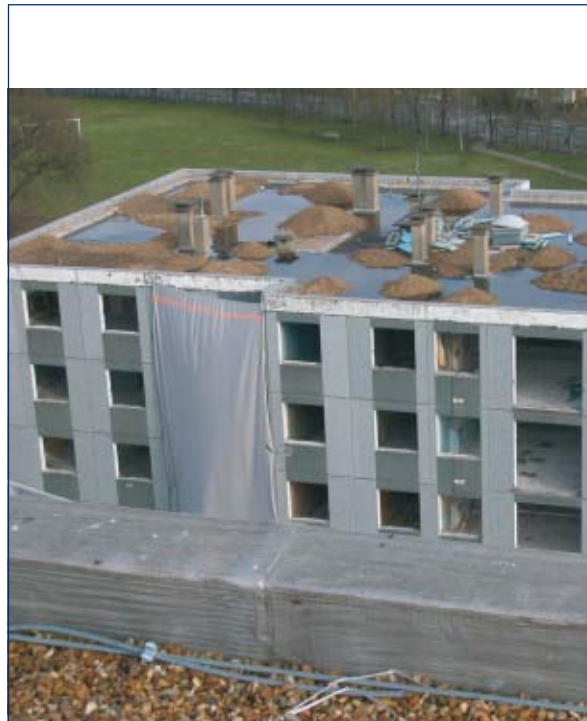
*Apartment building in Le Mans during deconstruction and demolition*

In Le Mans, the deconstruction and demolition of 2 identical apartment buildings dating from 1971 revealed a very low aluminium content. This was consistent with the global study observations that the northern European residential market uses considerably less aluminium than the southern European residential market and the pan-European commercial building sector.

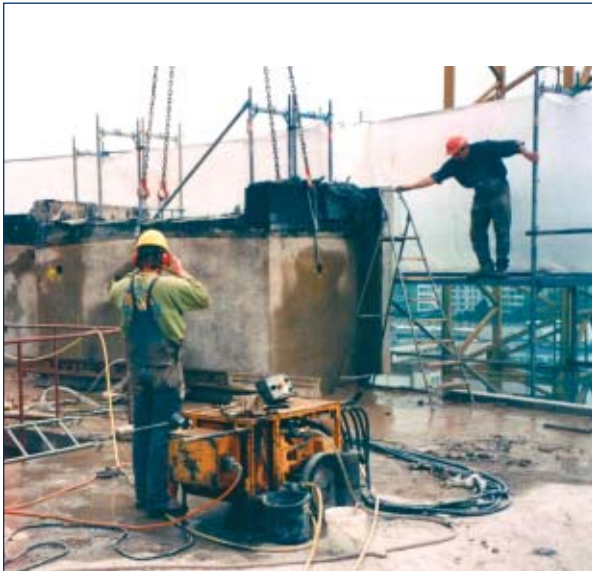
*Diamond sawing in Wuppertal*

Now that the deconstruction is complete, the demolition of clean concrete and brick can commence. Anything above the seventh floor is generally diamond-sawed into manageable pieces and lifted down with a crane. The lower levels, up to and including the seventh floor, are crushed between the claws of a hydraulic rock breaker and broken down into rubble. In some cases, an alternative method is applied where there are still considerable quantities of metal to be collected from exterior profiles. The walls of the building are then "folded" inwards, rather like the sides of a box, ensuring optimal recovery of aluminium. Finally, the site itself is checked for soil contamination and decontaminated, as necessary.

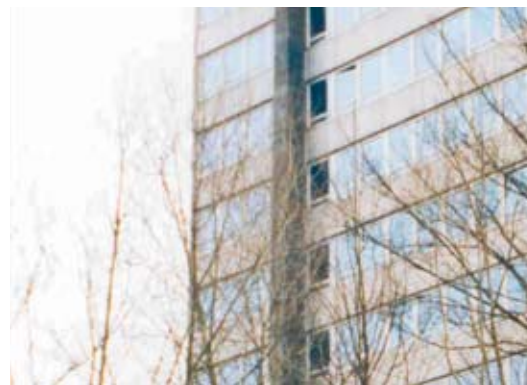
*Extensive exterior aluminium cladding*

The main feature of this property was its extensive exterior aluminium cladding, forming an envelope around the building, which accounted for almost half of all the aluminium found. This was closely followed by the windows, which also made up well over a third of the aluminium content. These exterior cladding panels and aluminium windows were not part of the original construction but had been added 10 years earlier. A vast number of small aluminium objects were also identified,

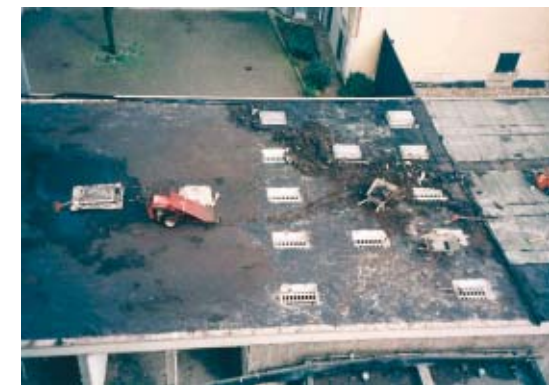
*Removal of hazardous waste from the roof of the courthouse*

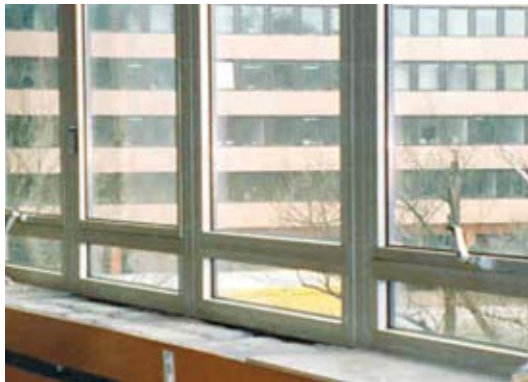
*Aluminium window frames in the Wuppertal courthouse*

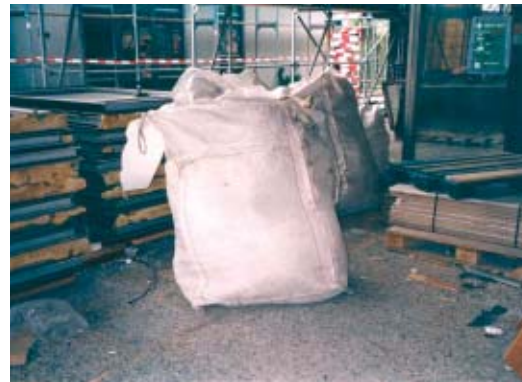
*Aluminium windows to be reused intact*

Because deconstruction was so meticulously accomplished by a reputable ISO-certified demolition firm, ECO-Soil, virtually all the materials found their intended destinations. All the aluminium components, large and small, were collected and sorted for resale, melting or shredding. The windows were not dismantled but sold as they were (aluminium and glass) to a buyer in Romania. Hence, an exceptionally high collection rate of 98% was obtained.

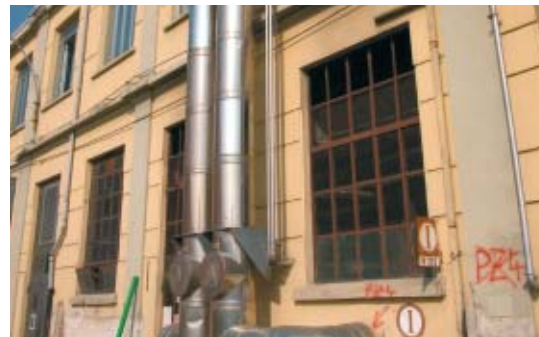
*Aluminium pipes and office windows in the Pirelli building*

The largest share of aluminium, amounting to 25 tonnes out of an overall inventory of 61.4 tonnes, was found in the office windows of the building, the majority of which was successfully recovered. A substantial proportion (almost a quarter of the total aluminium content) had been used as insulation cover for the 16 000 metres of insulated pipes running through the factory on the ground floor. Because these pipes contained both asbestos and mineral wool, they required extremely thorough specialized stripping, which in turn boosted aluminium collection. The same was true of the square ceiling plates and strips which accounted for approximately one-sixth of the aluminium inventory: mineral wool had to be separated from the aluminium, so the recovery of one material aided collection of the other. Considerable amounts of aluminium were also retrieved from partition wall profiles and door frames.

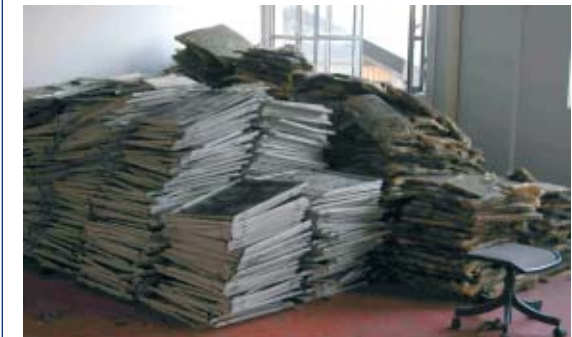
*Square aluminium ceiling plates stacked and ready for transportation*

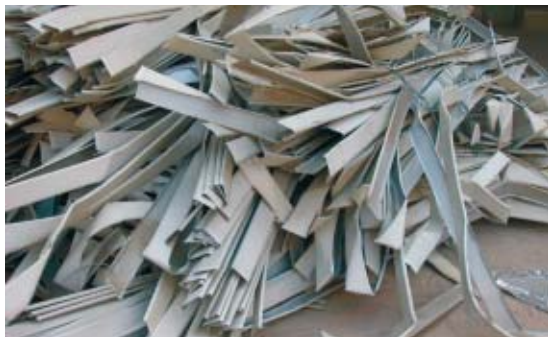
Aluminium ceiling strips in the Pirelli building

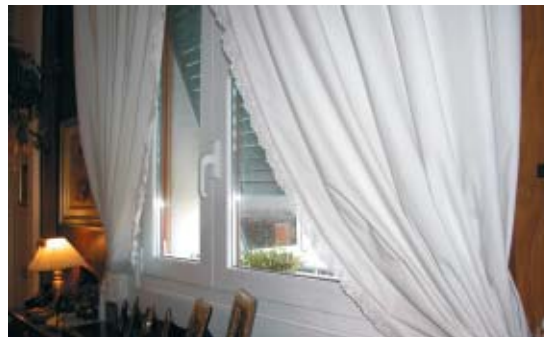
Aluminium window frame and shutters in a Milan apartment building

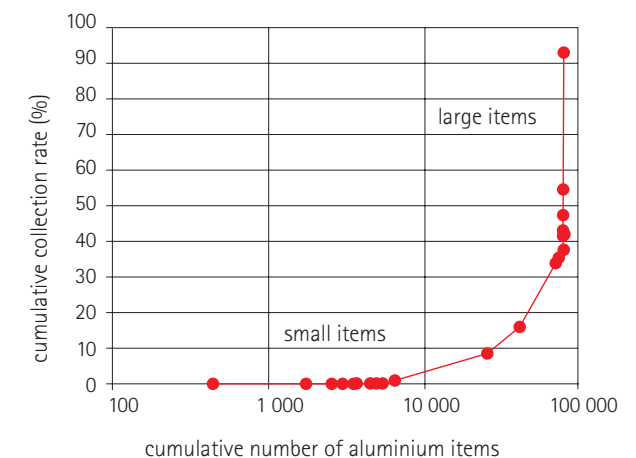
#### COLLECTION RATES OF PIRELLI BUILDING REPRESENTATIVE OF GLOBAL STUDY OBSERVATIONS

However, as these small components accounted for such a tiny proportion of the overall aluminium inventory of the building, the fact that they were not retrieved did not have any impact on the final collection rate. As was observed throughout the study, the best collection rates were systematically achieved from the recovery of larger pieces. Thus, from an aluminium share of 0.043% of the total building mass, a highly satisfactory collection rate of 94% was demonstrated.

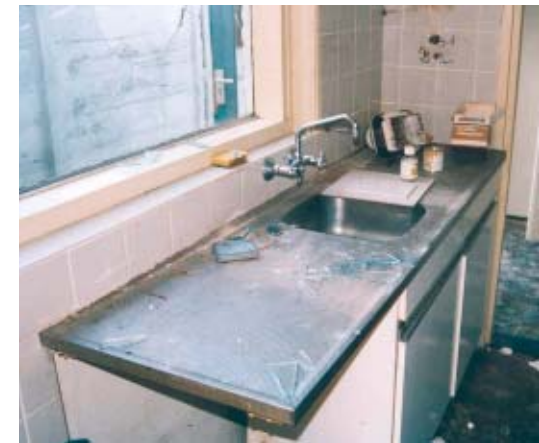
*Aluminium sink unit, door handles and window strips*

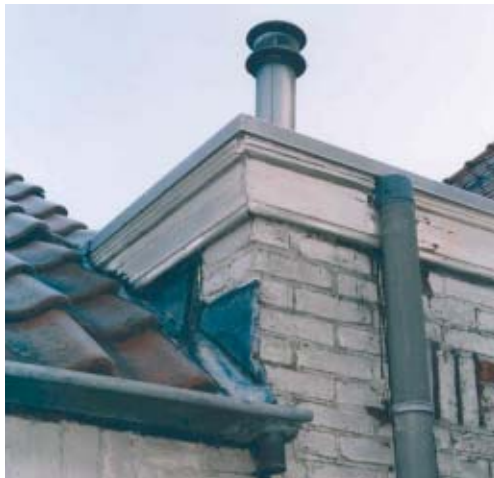
*Aluminium identified in roof strips and chimneys*

The aluminium found in these houses had actually been added several decades after the original construction. It had been utilized essentially for items like doors, kitchen sinks, strips and pipes, accounting for 0.0049% of the overall mass of a single house or a total weight of 8.7 kg per house. Since the houses were practically identical and the aluminium had always been used for similar applications, the final calculations could be based upon the mean figure obtained for just several houses.

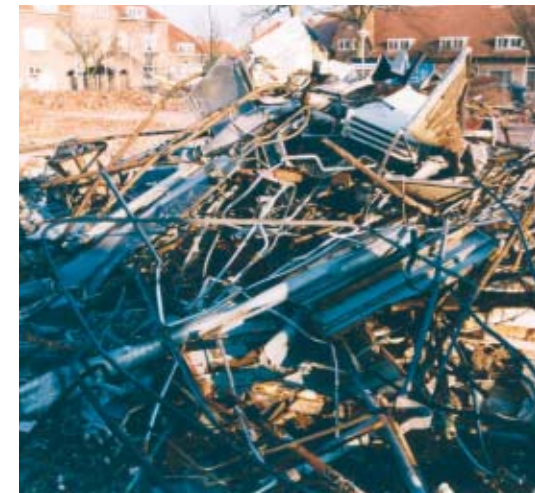
*Mixed metal scrap*

During deconstruction, separation procedures were extensively implemented, the metal components being initially collected in one mixed metal container, before being sent to a local scrap dealer for separation into individual fractions. Waste wood was also sent to a processing facility where all foreign materials, including aluminium, were retrieved to obtain clean wood for recycling. This type of processing is widespread in the Netherlands where waste wood recycling plants are routinely equipped with metal recovery machinery. Rubble was also similarly treated.

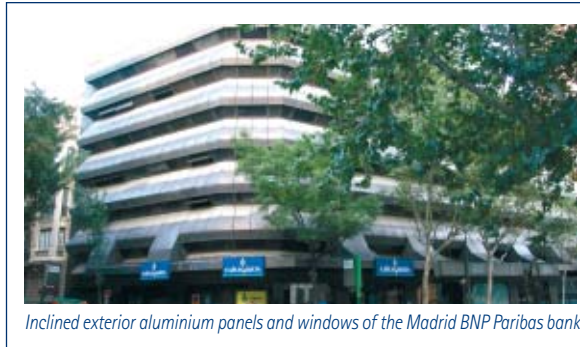
*Inclined exterior aluminium panels and windows of the Madrid BNP Paribas bank*

water supply. It had a rather striking appearance due to the rows of inclined exterior aluminium panels positioned above the windows on each floor, which easily accounted for the largest share of aluminium in the building. Each individual panel weighed between 60 and 80 kg so these panels alone made up more than half of the overall aluminium content, while over a quarter could be attributed to the windows and doors. The total aluminium inventory was calculated to be 92 tonnes, a very respectable 0.40% of the total building mass.

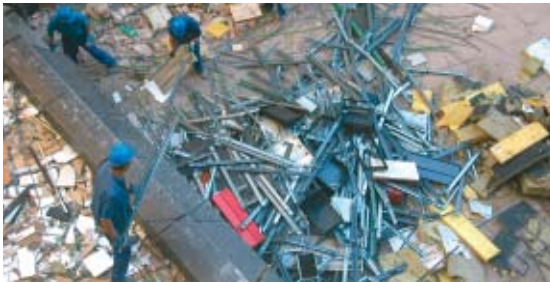
*Separation of metals*

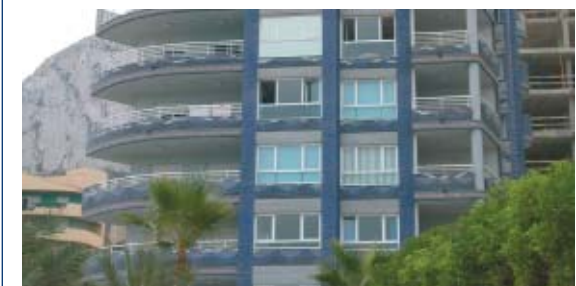
*Aluminium identified in windows and balcony fences in Alicante*

Residential housing in Barcelona and Alicante was also studied and found to contain significant volumes of aluminium in applications such as windows, roller shutters, sliding doors and fences. The apartments investigated in Alicante are brand new constructions which, although strictly classed as residential, could more accurately be described as semi-commercial, since many of them are used exclusively as holiday homes. Thus, these premises are very luxurious, incorporating a whole host

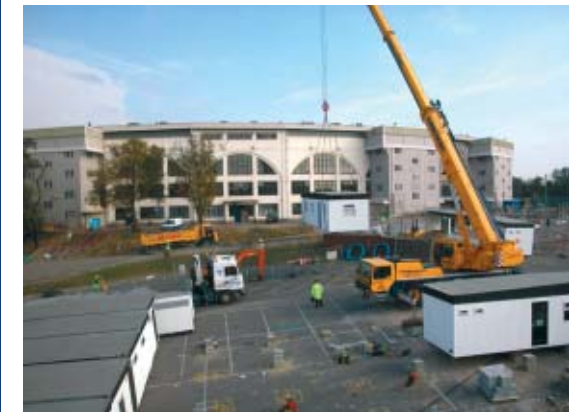
*Aluminium recovered from the roof of the stadium*

Substantial quantities of aluminium, amounting to 185 tonnes out of an overall inventory of 213 tonnes, were identified on the roof of the stadium, which was constructed of a steel cantilever covered with aluminium plates. This vast amount accounted for the principal share of aluminium found in this arena, though a significant volume was also detected in the windows and doors. Such distribution is quite typical of that encountered in most sizable commercial premises where one or two larger categories of components account for the lion's share of collectable aluminium, while smaller objects are frequently lost to recovery.

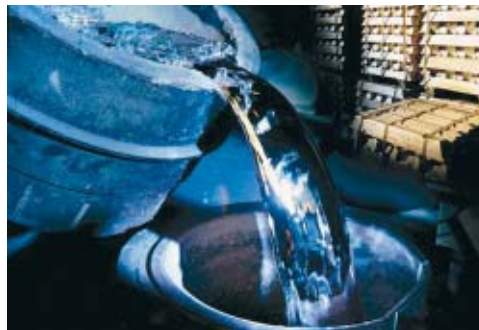
*Recycled aluminium poured into ingots for use in new applications*
